Joel Stoltzfus¹

Fires in P-3 Aircraft Oxygen Systems

ABSTRACT: Fires in three P-3 aircraft oxygen systems have occurred: one in the Royal Australian Air Force (RAAF) in 1984 and two in the U.S. Navy in 1998 and 2003. All three fires started in the aluminum manifold and check valve (MCV) assembly and produced similar damages to the aircraft in which they occurred. This paper discusses a failure analysis conducted by the NASA Johnson Space Center White Sands Test Facility (WSTF) Oxygen Hazards and Testing Team on the 2003 U.S. Navy VP-62 fire. It was surmised that the fire started due to heat generated by an oxygen leak past a silicone check valve seal or possibly because of particle impact near the seat of one of the MCV assembly check valves. An additional analysis of fires in several check valve poppet seals from other aircraft is discussed. These burned poppet seals came from P-3 oxygen systems that had been serviced at the Naval Air Station (NAS) in Jacksonville following standard fill procedures. It was concluded that these seal fires occurred due to the heat from compression heating, particle impact, or the heat generated by an oxygen leak past the silicone check valve seal.

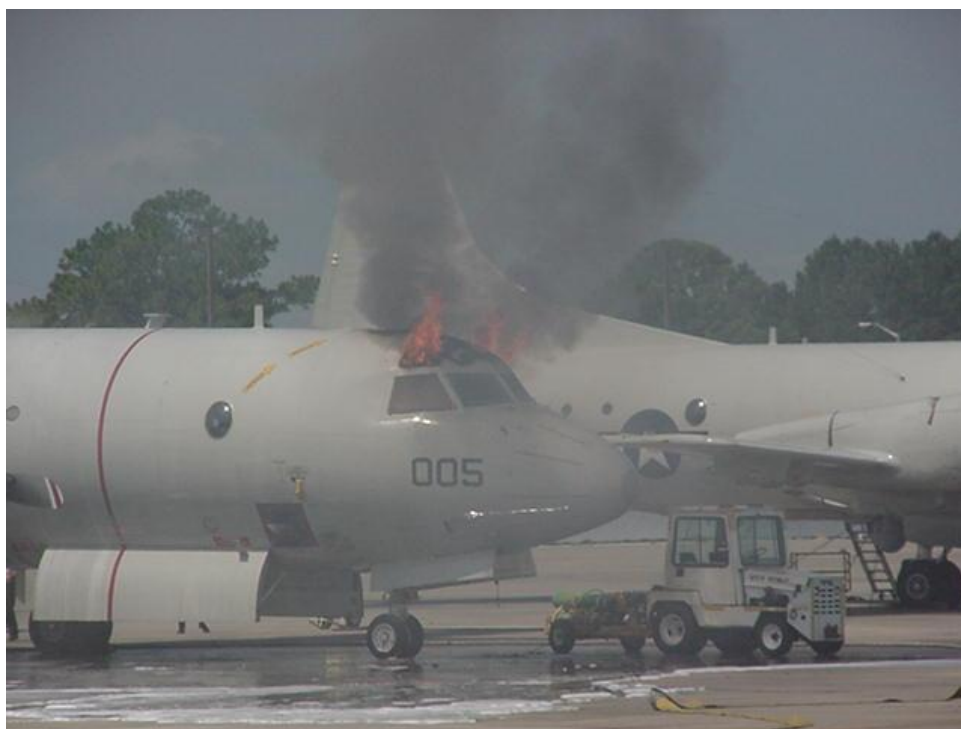
The fire damages to the aircraft are shown in Figures 4 through 7. Fig. 4 shows the burning aircraft, and Fig. 5 shows the exterior damages to the aircraft. It is apparent the damage is centered in the location of the flight station oxygen system. Fig. 6 shows the damaged oxygen system looking inboard through the burned holes in the aircraft skin. Fig. 7 shows the damaged MCV assembly. The body of the inlet manifold in the vicinity of check valves 2 and 3 is burned through from the inside-out. The poppet or check valve 3 is missing. The burn patterns in the aircraft indicate this is the location of the first burn-through and provide strong evidence this manifold is the location of the initial fire.

FIG. 4—*Fire in P-C3 aircraft at NAS Jacksonville.*

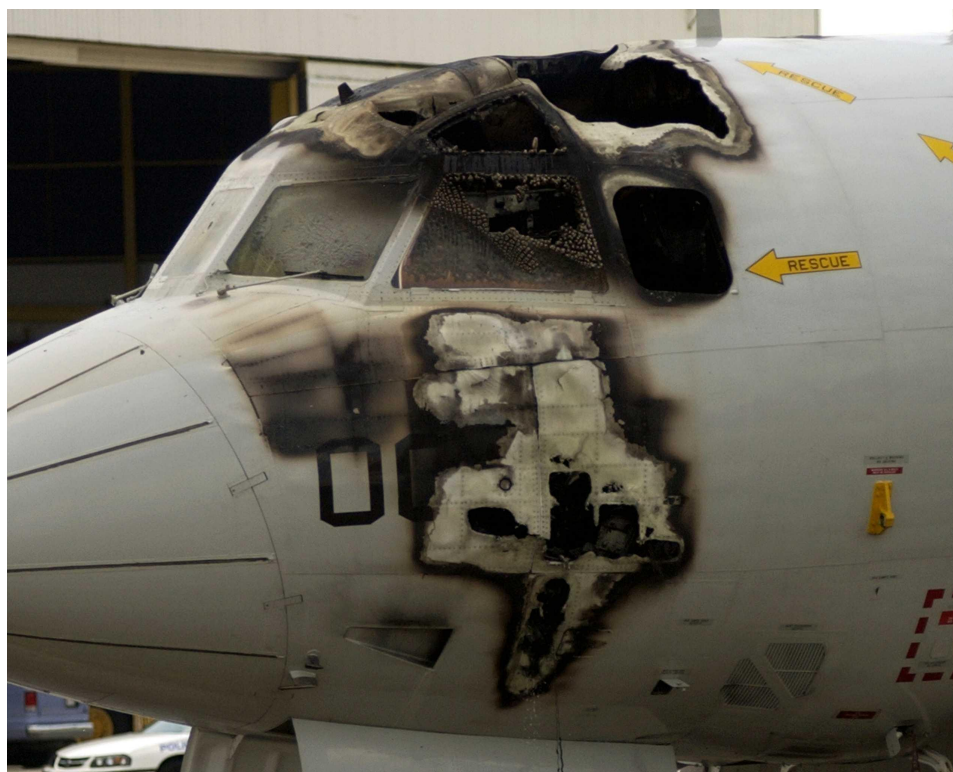
FIG. 5—*Exterior damages caused by flight station oxygen system fire.*

As noted previously, the damages to the aircraft were centered in the location of the flight station oxygen system [Fig. 5] and the MCV assembly was the central location from which the fire emanated. A large portion of the MCV assembly was burned away [Fig. 7] and the component appeared to have burned from the inside out. The oxygen fill valve was intact, as were the overboard discharge indicator, the pressure reducer assembly, the oxygen cylinder and valve assembly, the diluter demand oxygen regulators, and the smoke mask assemblies. The damages to the tubing in the vicinity of the MCV assembly could be easily explained as collateral damages occurring after the fire burned through the MCV assembly wall. Therefore, the MCV assembly was postulated as being the origin of the fire.

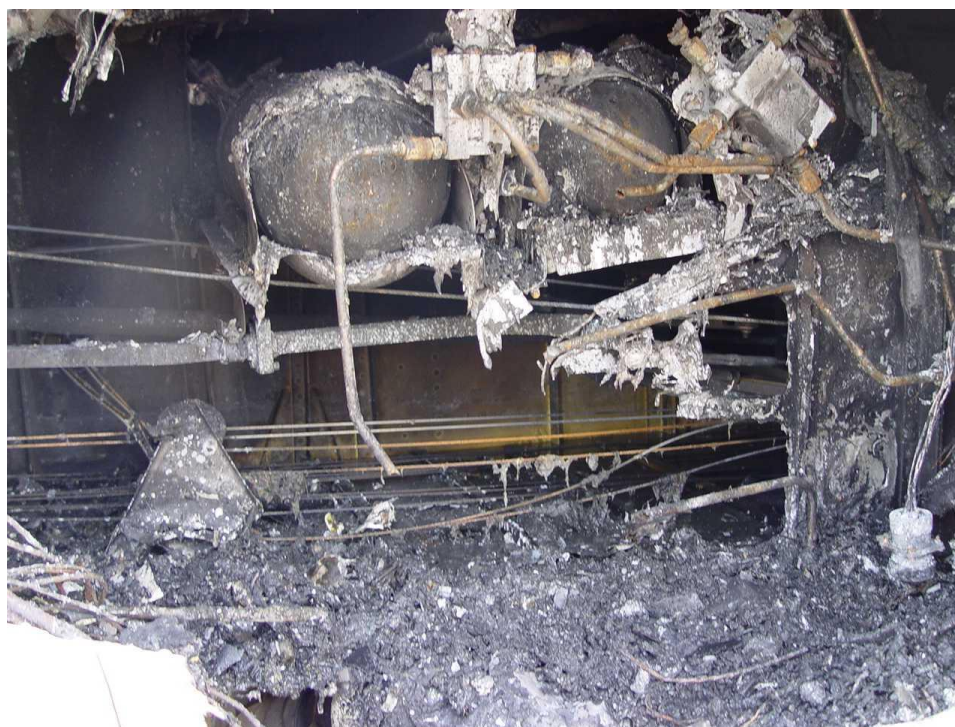
FIG. 6—Damages to flight station oxygen system components looking inboard through the holes (some of the damaged aircraft skin have been removed) in the aircraft exterior shown in Fig. 2.

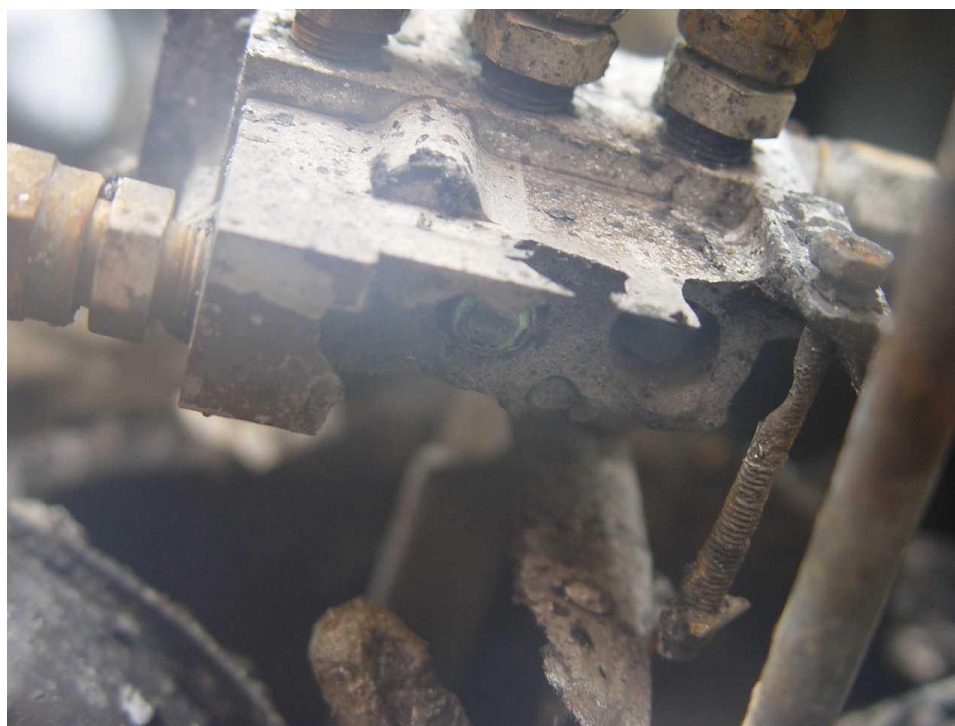
FIG. 7—Damages to the MCV assembly.

It is apparent that a kindling chain reaction did occur in the flight station oxygen system since the inlet manifold of the MCV assembly was burned out. The physical evidence is consistent with a fire starting in the seat of check valve 3 (probably by flow friction, or in check valve 2 or 3, possibly by particle impact). This fire propagated to the aluminum poppet or the stainless steel retainer screw to the aluminum MCV assembly body. The fire burned through the MCV assembly body, releasing pressurized oxygen and the accompanying burning debris to the cabin. Several torches of flame and debris developed as the oxygen flowed out of the cylinders through the burned breeches in the system.

Because of this dramatic kindling chain and the two fires of similar origin and magnitude that had occurred previously in the RAAF and U.S. Navy, the MCV assembly was recommended to be replaced with one made from a burn-resistant material, such as Monel 400 or Monel K-500. Such a replacement would harden this system against ignition and burn propagation and dramatically reduce the likelihood of a catastrophic fire occurring. This recommendation, which was also made after the analyses of the previous fires, has been implemented. The entire U.S. and Canadian fleets of P-3 aircraft have been retrofitted with Monel-bodied MCV assemblies with an upgraded design and more burn-resistant materials.

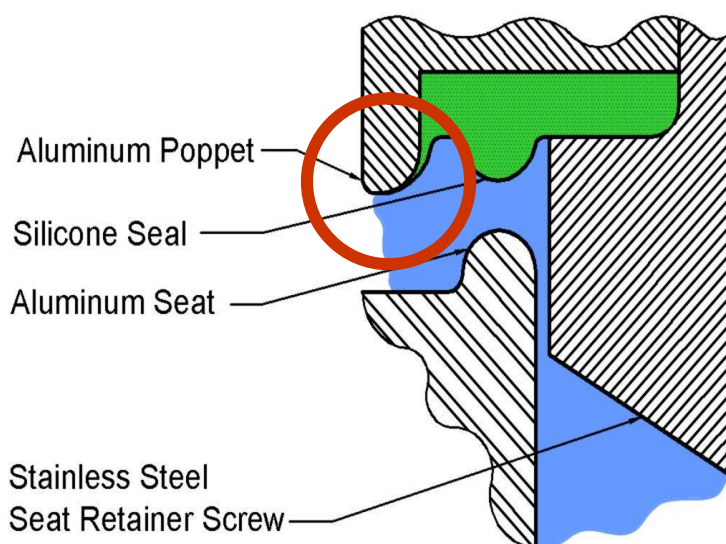
In this case, the pressure drop from the center manifold to the inlet manifold was as high as 1 900 psi (13 000 kPa) due to leakage in the inlet line. A small leak from the center manifold to the inlet manifold across the silicone seat of check valve 3 was probable. Flight line technicians reported such leaks are common and often measures are taken to stop such leaks. This was explicitly the case in the U.S. Navy VQ-11 fire incident previously mentioned. It was surmised that a similar leak existed in this check valve as well. The silicone seat material in the MCV assembly check valves has a relatively low ignition temperature, 504 °F (262 °C). Additionally, a “ribbon” of silicone material exists at the outer diameter of the molded silicone seal that could produce heat if vibrated by the flow and constrained by the poppet and seat. Fig. 8 provides an illustration of an open MCV assembly check valve and indicates where a “ribbon” of silicone material may be developed. Therefore, ignition by flow friction was concluded to be highly probable.

FIG. 8—Cross-sectional view of an MCV assembly check valve seat. The encircled area indicates the location where a “ribbon” of silicone material may be developed.

- 2) Leak of “weeping” flow across external or internal seals: Fig. 8 illustrates the check valve seals are configured so a delaminated ribbon of silicone can easily be formed and oxygen could flow between this delaminated ribbon and the poppet body.
- 3) Exposed nonmetal in the flow path: The silicone seal material is exposed to the leaking oxygen.

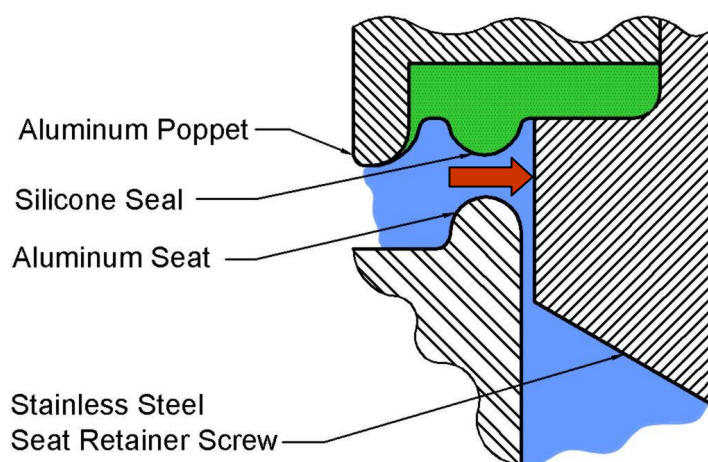
In this case, all the characteristic elements could have existed in this component. That particles existed in the component was indicated by examination of exemplar units, which contained particulate contamination. The pressure drop across a possibly leaking seat from the center manifold to the inlet manifold would generate a high gas velocity. A high-velocity particle could have impacted the stainless steel seat retainer screw as shown in Fig. 9. The stainless steel screw is flammable at 1 900 psig (13 000 kPa) and the particle was assumed to have been flammable. Ignition by particle impact was concluded to be possible.

FIG. 9—Cross-sectional view of the MCV assembly check valve poppet. The arrow indicates a possible particle impact location.

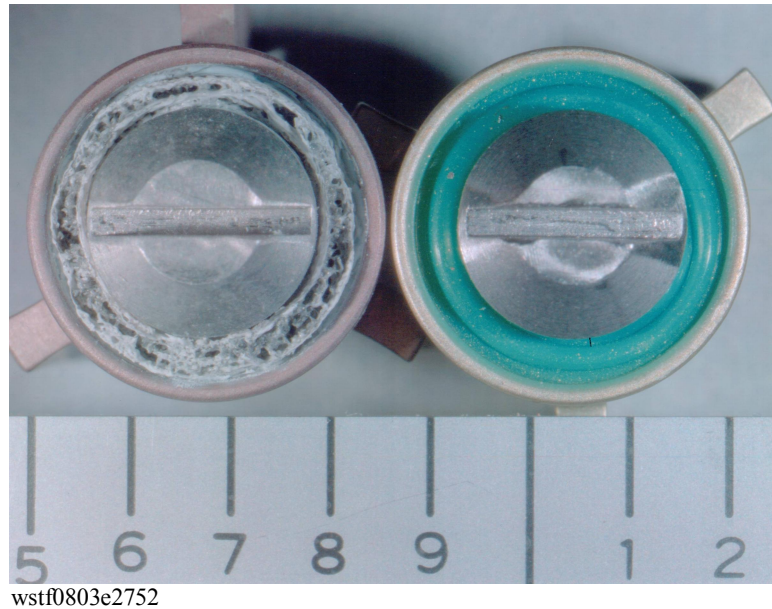
During the performance of the failure analysis on the VP-62 flight station oxygen system fire, WSTF personnel received twelve check valve poppets from NAS Jacksonville personnel. Eleven of the twelve poppets were damaged. Fig. 10 shows a typical damaged poppet and an undamaged poppet.

FIG. 10—A typical damaged MCV assembly check valve poppet (left) and an unused, undamaged poppet (right) as shown with a scale in inches.

- 1) Particles in the flowing oxygen: These check valves were contaminated. See the contamination in Fig. 10 and Fig. 12.
- 2) High gas velocity: If a leak was occurring across the silicone seal into a low-pressure inlet manifold, sonic velocity could occur.
- 3) Impact point and residence time: Particles could impact on the side of the stainless steel seat retainer screw and reside there momentarily (Fig. 9).
- 4) Flammable particle and target: The stainless steel screw is flammable.

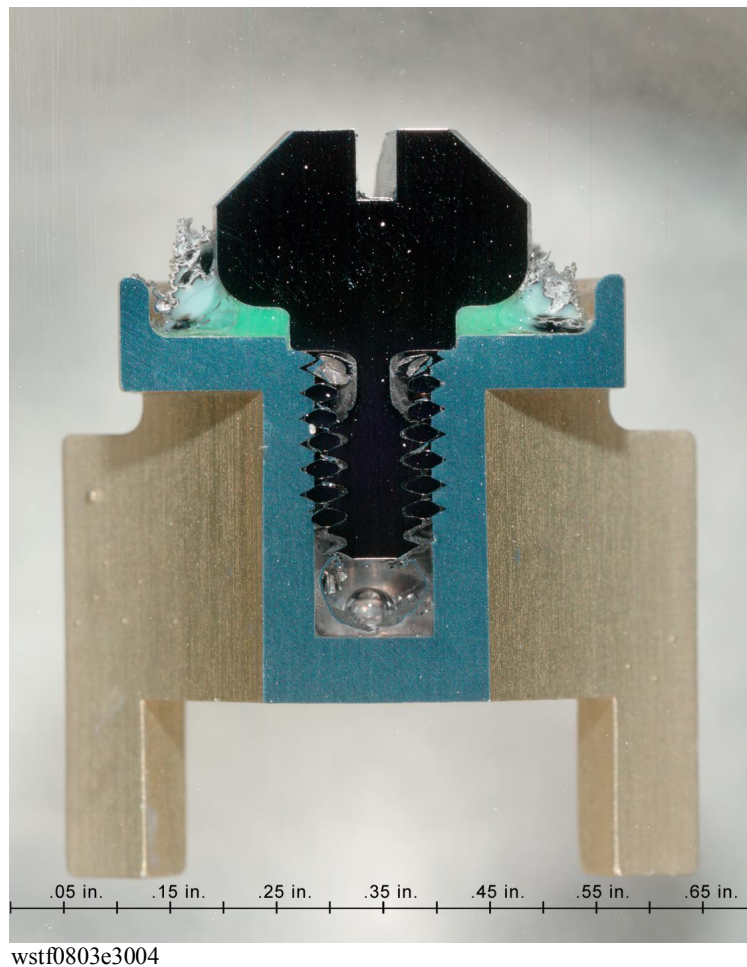
A cross-sectional view of one of the eleven damaged poppets is shown in Fig. 11. It can be seen that the green silicone seal is damaged. Further observation revealed the silicone seal had been, in fact, partially burned. However, the fire damage did not propagate to consume the entire silicone seal nor did it propagate to the aluminum alloy check valve poppet or the stainless steel seat retaining screw.

FIG. 11—Cross-sectional view of a burn-damaged MCV assembly check valve poppet.

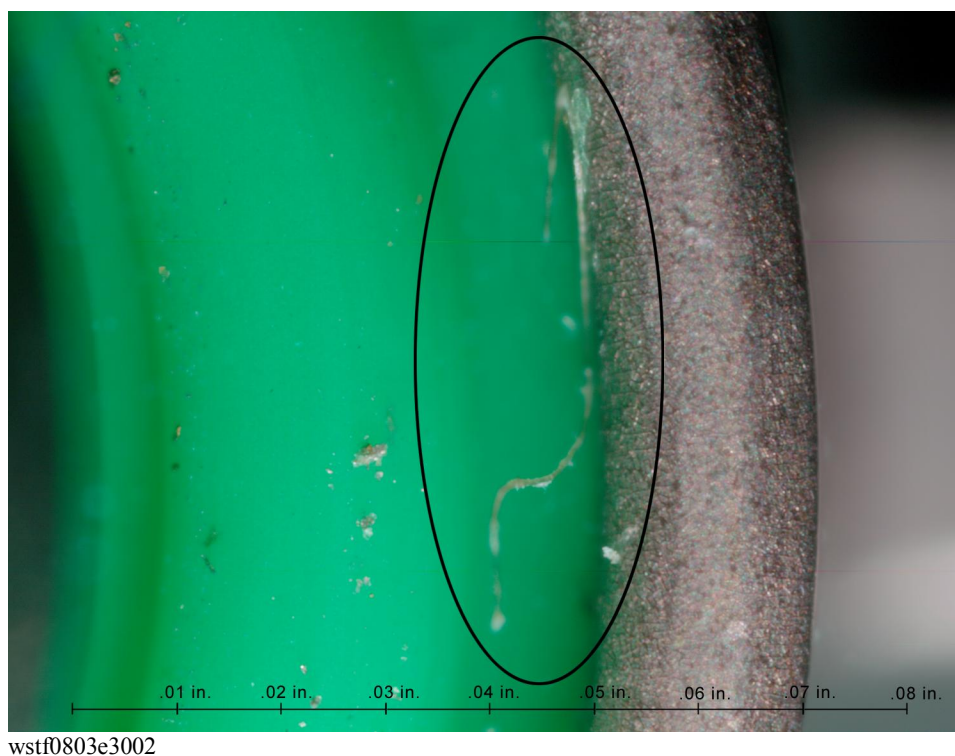
As was previously mentioned, recent experiments at WSTF indicate pressurized gas flowing past a ribbon of elastomeric material can cause a vibration of the material. If, in another location near the leak, the vibrating material is partially constrained from moving it will be heated at the point that the constraining part touches the elastomer. In preliminary experiments using 30 psig (310 kPa) air flowing past a ribbon of silicone material, heat damage to the silicone material was observed. This scenario is present in the MCV assembly check valve seal. Fig. 12 shows a close-up view of a delaminated fiber of silicone seal material that may have been damaged by heat from this postulated ignition mechanism.

Flow friction heating was considered a highly probable cause of the fire damages observed in the eleven MCV assembly seals.

FIG. 12—Close-up view of delaminate fiber of silicone seal material showing possible heat damage due to postulated flow friction heating.

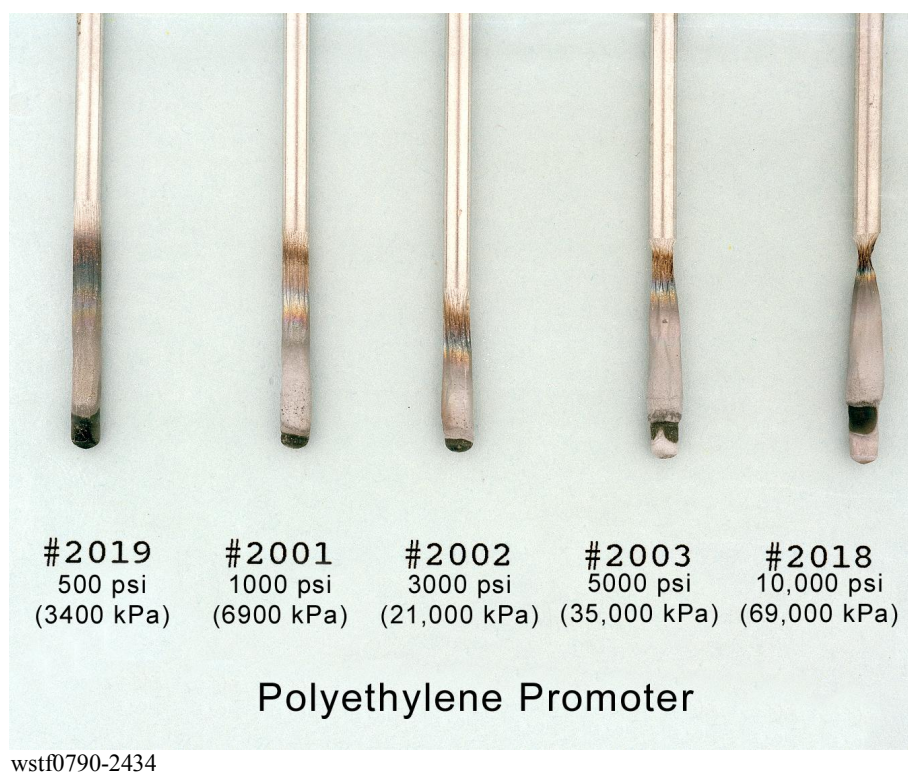
The anodized layer on the aluminum poppet body was surmised to have protected it from burning. The literature data indicate aluminum oxide is a coherent protective oxide that must be breached before ignition of the metallic aluminum substrate material can occur [10]. An anodized layer has been found to provide additional protection against the ignition of aluminum even beyond that provided by the naturally occurring oxide [11]. In addition, tests have been performed at WSTF in which high-density polyethylene ignition promoters were pressed over the ends of aluminum rods and ignited in oxygen at up to 10 000 psi (69 000 kPa). The rods were suspended vertically from the top and the polyethylene promoters were located at the bottom end of the rods. In most cases, see Fig. 13 for an example of five rods, the aluminum rod melted and deformed but did not ignite.

Analysis confirmed the aluminum oxide film, even though it was obviously thermally softened and deformed, provided an ignition-inhibiting barrier between the aluminum and the oxygen. This protective oxide film of both naturally occurring and chemically applied oxides is thought to be what prohibited the propagation of the fire in the eleven MCV assembly check valve poppets.

FIG. 13—Aluminum rods that did not ignite when exposed to burning polyethylene at various oxygen pressures.
